PROJECT
DANE COUNTY
DAY RESOURCE CENTER
1326 E WASHINGTON AVE
MADISON WISCONSIN

DRAWING
EXTERIOR ELEVATIONS

A1.0

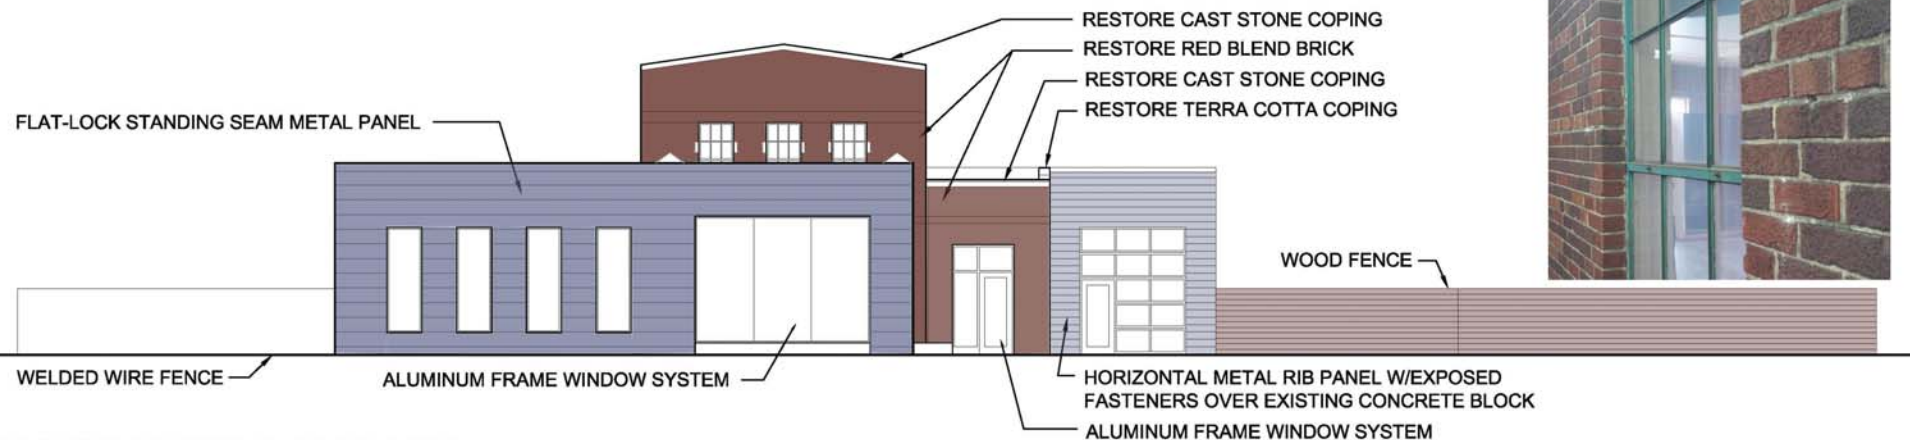
① EAST WASHINGTON AVENUE ELEVATION (SOUTH)
1/8"=1'-0"

FLAT-LOCK STANDING SEAM METAL PANEL
